## Refurbishment Horizontal Split Case Pump

**WORTHINGTON PUMP 12LNV29 DRIVEN BY  
SIEMENS 1500KW SLIP RING MOTOR**

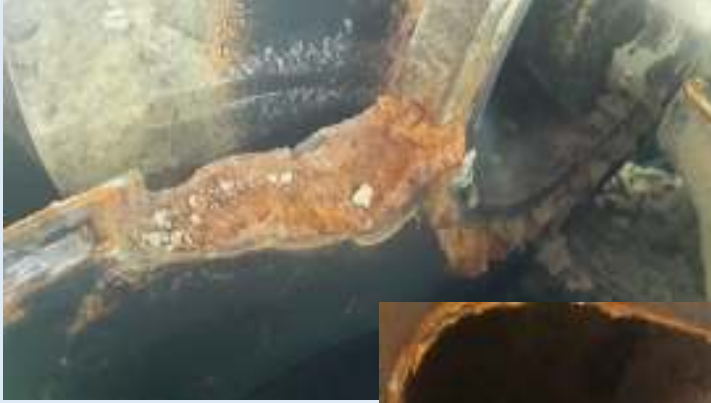
*Corrosion Caused  
By Improper Gasket Cutting*
